Case 279 : Narrative

Case Vehicle (A): 2001 Ford	Veh. (B): 1993 Pontiac
Type: Explorer Sport, 4 x 2, 2-door SUV	Type: Bonneville SE, 4-door sedan
Driver: 38-year-old female	Driver: 34-year-old male
CDC: 12-FDEW-2	CDC: 04-RZAW-4

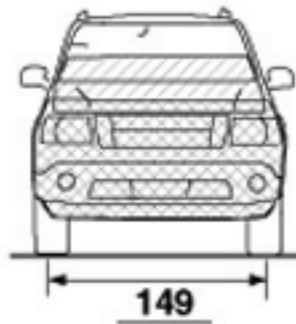
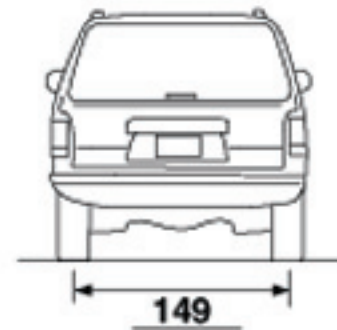
3 Damage to case vehicle (A) was moderate. Direct damage began at the left-front bumper corner and extended 148 cm to the right, across the entire frontal plane. 4 The maximum crush was 26 cm and occurred at the left-front bumper corner.

Max. crush to left
front bumper corner
